AIRCRAFT ACCIDENT REPORT

**UNCONTAINED ENGINE FAILURE/FIRE
VALUJET AIRLINES FLIGHT 597
DOUGLAS DC-9-32, N908VJ
ATLANTA, GEORGIA
JUNE 8, 1995**

Abstract: This report explains the uncontained engine failure/fire on ValuJet Airlines flight 597, a Douglas DC-9-32, N908VJ, at Atlanta, Georgia, on June 8, 1995. The safety issues discussed in the report include the clarity of operations specifications for repair stations, recordkeeping requirements for foreign repair stations, regulatory guidance concerning maintenance documentation, intent of "serviceable tags," independently powered public address systems on all transport-category airplanes, flight attendant training programs and manuals, enforcement of occupant restraint requirements, notification of flightcrew of cabin fire, cabin material/fire safety standards, flight attendant attire, and quality of cockpit voice recordings. Safety recommendations concerning these issues were made to the Federal Aviation Administration (FAA).

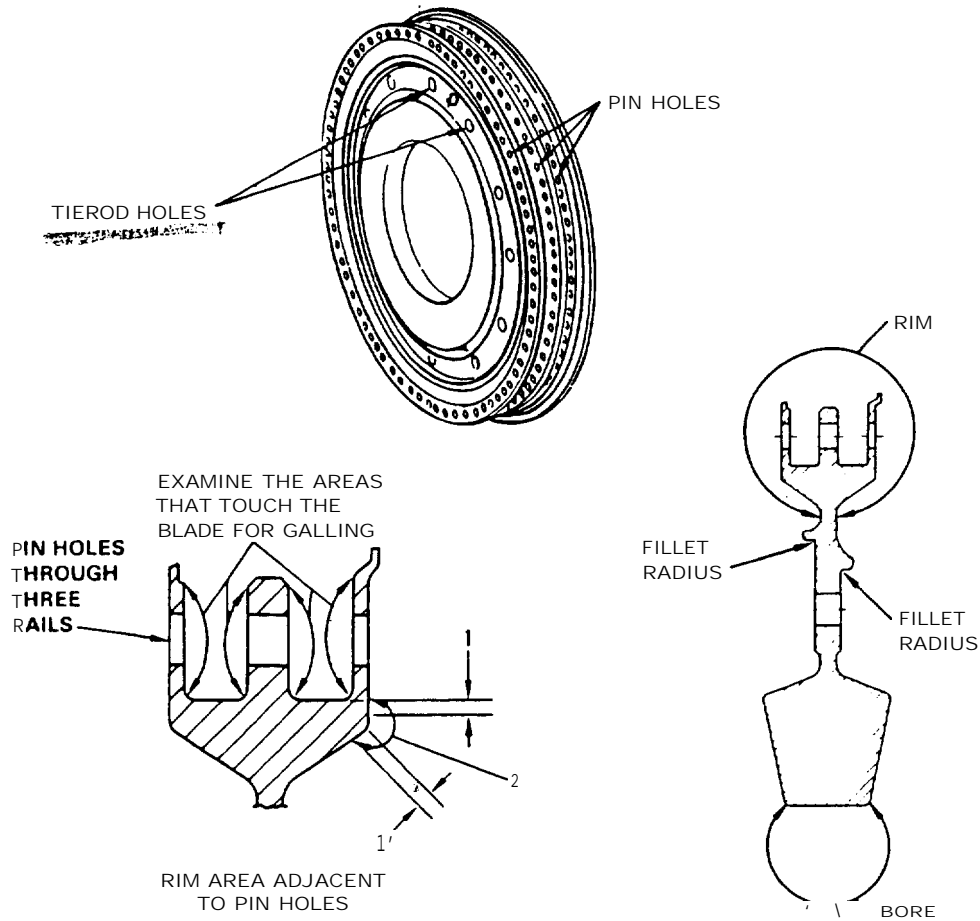
Pratt & Whitney
JT8D ENGINE (PN 481672 - RESTRUCTURED)
COMPRESSOR DISK, STAGE 7 - INSPECTION-01

The P&W engine manual specifies that for area 7 of the P&W figure 802 (see appendix D), which is depicted as a tierod hole, no unrepaired damage can be allowed in any hole, or within 0.125 inch of the edge of the hole on adjacent surfaces, and that damage can be repaired to a depth of 0.005 inch by blending. The instructions further indicate that damage up to 0.003 inch is acceptable in the web area of the disk without blending. The cross-section of the 7th stage disk in P&W figure 802 depicts the tierod holes, but does not have the hidden lines,²⁹ which would depict the smaller diameter SR holes behind the tierod holes, or a separate cross-section of the disk, just through the SR holes.
